Support for implementing measures for the South East Europe Core
Regional Transport Network Multi Annual Plan 2008-2012
EuropeAid/125783/C/SER/MULTI

SAMPLE ROAD SAFETY INSPECTION REPORT

Annex 3 to Road Safety Inspection Guideline

Sample Road Safety Inspection Report

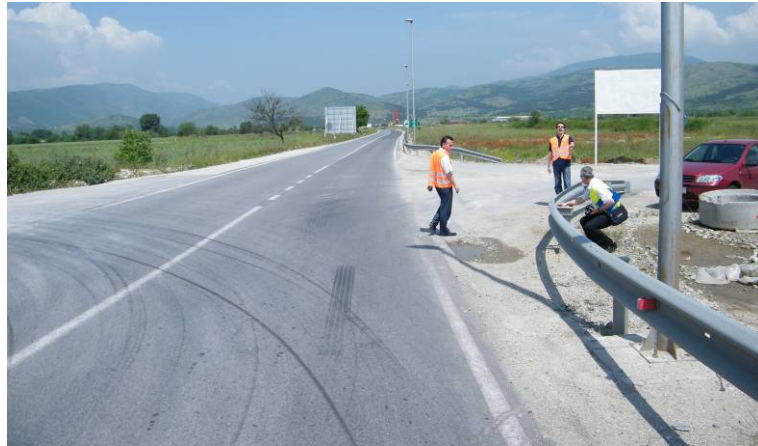
- Design of road is not suitable for its today function (it was built in '60).
- Too many small accesses without appropriate design and signs (access to private properties and farmland). *GPS: My loc. 02, 08, 10, 12 and 15.* The possibility of usage access to the farmland from backwards should be checked.

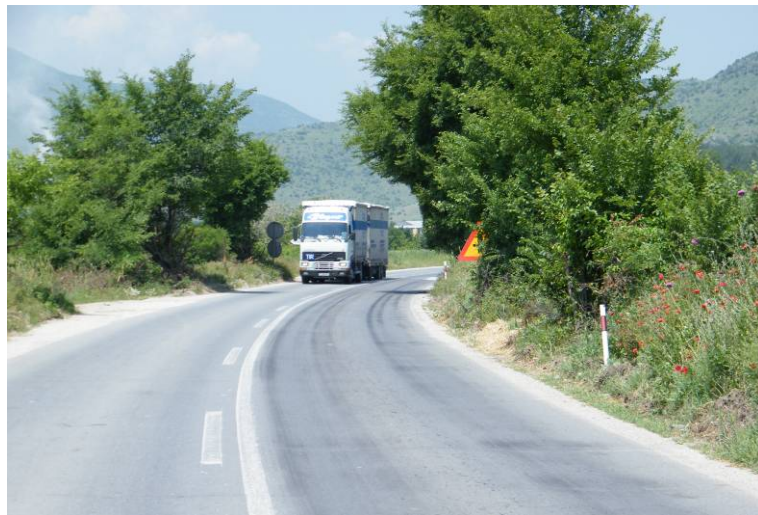
- Orientation sight is partly not guaranteed, because of the sight obstruction by the vegetation. *GPS: My loc. 13.*

- Speed limits and their location should be checked. Speed limit sign 60 km/h (*GPS: My loc. 13*) should be moved up to for about 300 m. Speed limits should be repeated after intersection (road to "truck terminal") *GPS: My loc. 14.*
- All access roads should be checked (closed or legalized with appropriate signalization).
- Problems in curves, stopping sight distance are obstructed by the vegetation.
- Obstacles: Trees and direction signs are in road safety zone.

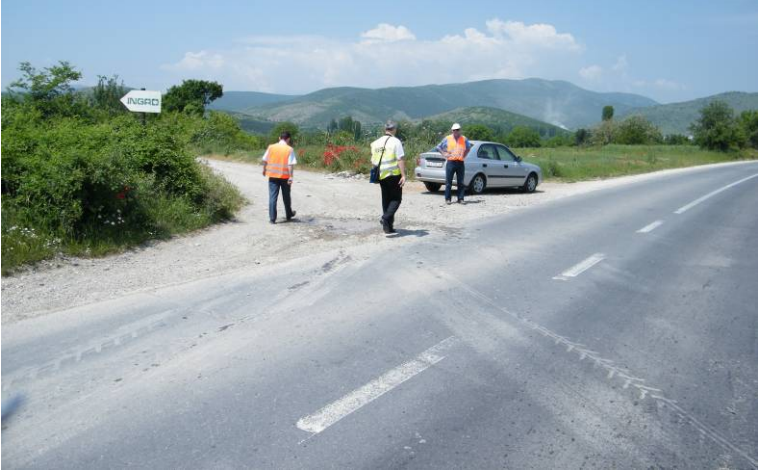
<p>4. Intersections, Traffic lights, Railway crossings</p>	<ul style="list-style-type: none"> • There are few small (agriculture) intersection (at some of them right of way was not signed - stop signs are missing). <div style="text-align: center;">

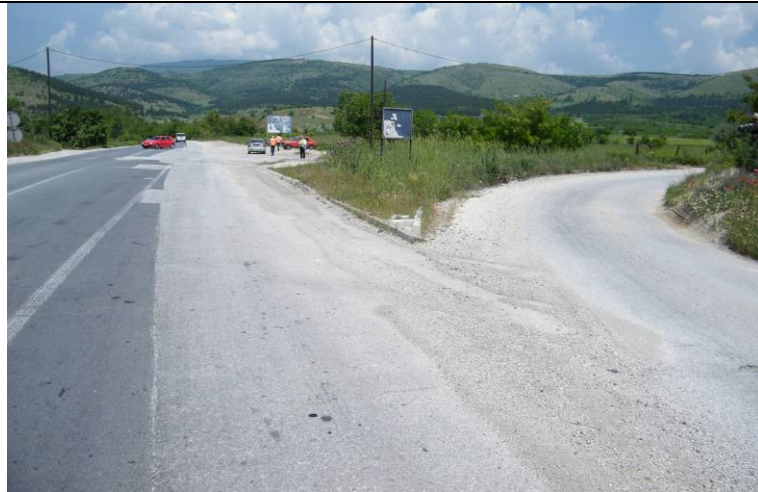
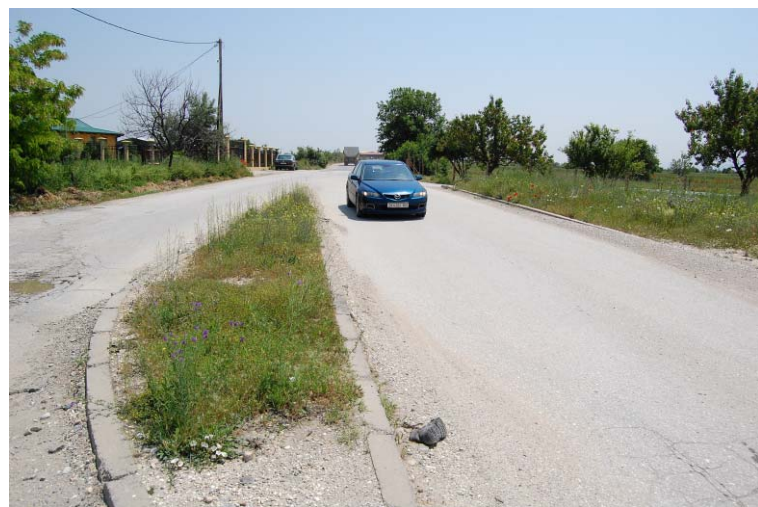
</div> <ul style="list-style-type: none"> • One bigger intersection with the road to the truck terminal has some curbed islands. There is space for a left turning lane and a taper for right turning but no clear guidance by marking and signing as well as no direction signs. Pot holes are present at secondary road. • Intersection (road to truck terminal) is in an acceptable way visible and recognizable.

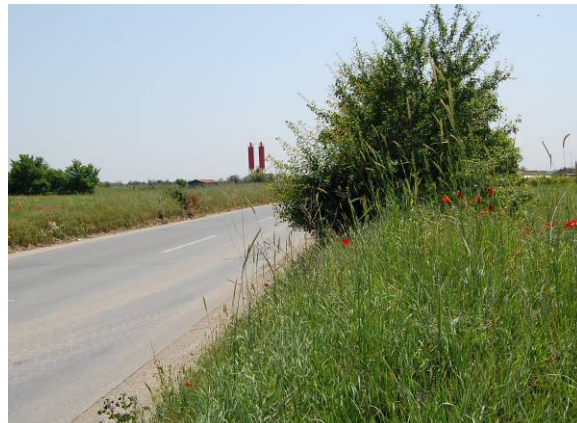
- In the most cases no sufficient sight conditions for the agricultures and plant roads (sight was obstructed by) vegetation, pls see below example for a "driver view".

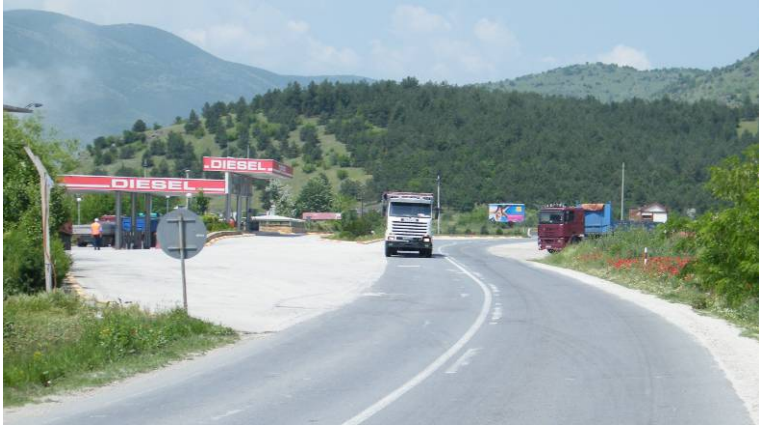
<p>5. Traffic signals 6. Railway crossings</p>	<ul style="list-style-type: none"> No facilities, no comments
<p>7. Service and rest areas</p>	<ul style="list-style-type: none"> At the end of inspected section (near by gasoline station, <i>GPS: My loc. 15</i>) service and rest areas are at one side of road and parking facilities are on the other sides of the road. There is no left lane for the gasoline station (but the asphalted width would be sufficient for this). No clear definition of organization in gasoline station and parking.

<ul style="list-style-type: none"> Deceleration and acceleration lanes at the entrance and exit are not defined (right of way was not defined). The sight at parking and gasoline station can be obstructed by parked vehicles.
<p>8. Public transport 9. Needs of vulnerable Road users</p>	<ul style="list-style-type: none"> No facilities, no comments
<p>10. Traffic signing, marking and lighting</p>	<ul style="list-style-type: none"> Visibility of the road esp. at night should be improved by adding the delineators. Some stop signs are missing at access roads, and some speed limit signs (signs and markings should be the same for the both direction). There are no information signs for gasoline station and parking area. Vegetation causes the problems to the sign visibility. Signs retro reflective function should be checked. There are problems with big directional signs (solid obstacle-like structure of poles).

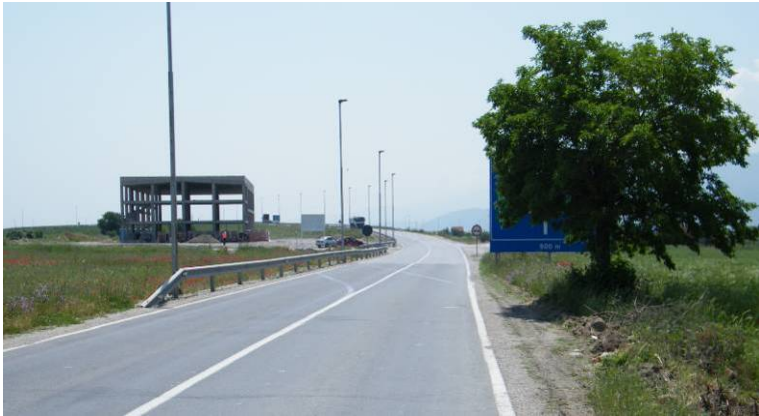
</div> <ul style="list-style-type: none"> • Markings should be renewed through regular maintenance (once per year). Edge line should be marked. • There are some phantom markings at old by pass roads. • Horizontal and vertical signalization must be correspondent (contradictions with overtaking are found).
<p>11. Road side features</p> <p>Civil engineering structures Plantings and trees Other obstacles</p>	<ul style="list-style-type: none"> • There are some dangerous features within the safety zone (direction sign and tree). <div style="text-align: center;">

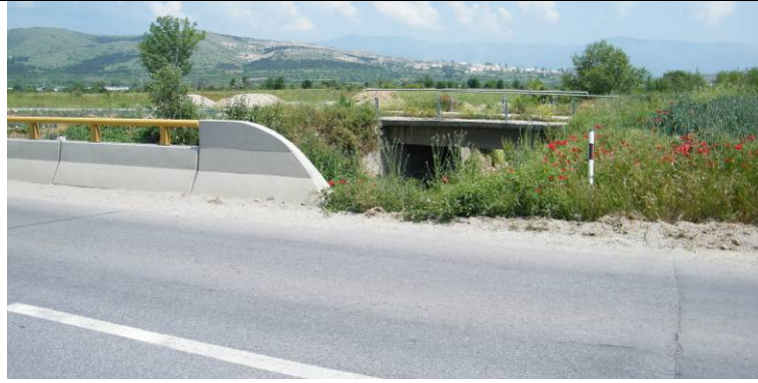
</div> <ul style="list-style-type: none"> • Vegetation along the road can cause the visibility problems. Sight is obstructed by the planting (vegetation) in curves and at intersection (agriculture) roads. • At the small bridge is a concrete barrier installed, but some extension with steel guard rail before and after the bridge

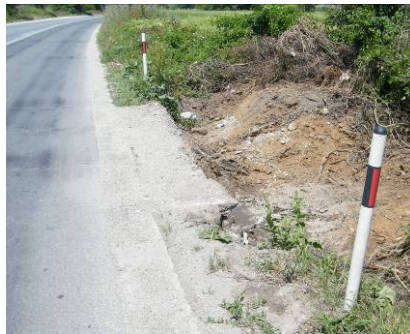
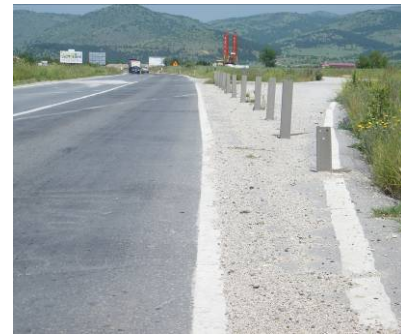
- At the two culverts (GPS: My loc. 09) guard rail should be installed.

- Some guard rail poles are considered as obstacles (GPS: My loc. 05 and 07).
- Guard rail should be added at the bridges area, culverts protection and big direction sign.
- Guardrail start and end treatment are not according the safe standards (should be improved towards EU norms EN 1317). One beam was welded, it is dangerous, bolted connection are insufficient, in a case of a hit the function can not be guaranteed
