Support for implementing measures for the South East Europe Core
Regional Transport Network Multi Annual Plan 2008-2012
EuropeAid/125783/C/SER/MULTI

COLLECTION OF RESULTS AND EXAMPLES FROM THE RSI PILOTS IN THE SEETO REGION

Annex 4 to Road Safety Inspection Guideline

July, 2009

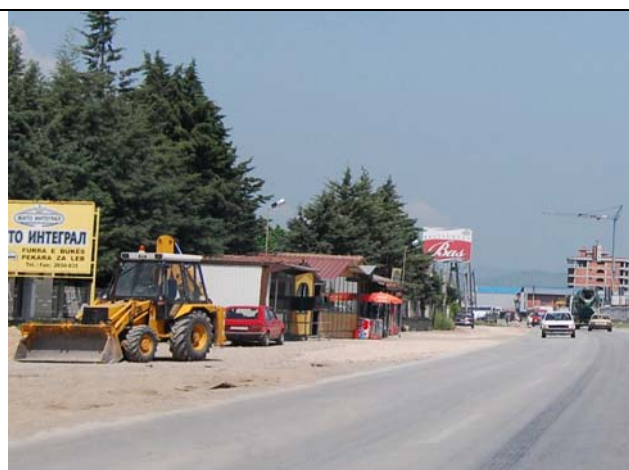
Figure 2.1. Interurban road near by a city – unorganized access situation

Problem: unorganized development of trading and business activities, the roadside is "occupied" as a big access area

Proposal for improvements: Reorganizing access from secondary access road network, reduction better closure of the access

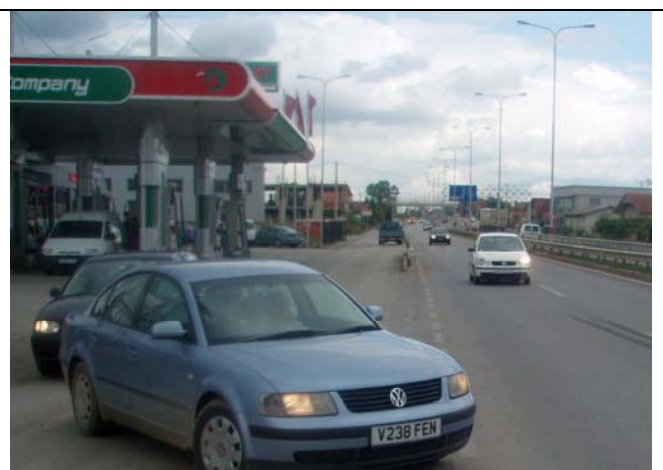
Figure 2.2. Express road with parallel service road but direct access from a petrol station to the main carriageway

Problem: The two carriageway express road has parallel services roads, but the costumers of a petrol station have direct access to the main carriageway

Proposal for improvements: Closing the direct connection, improvements regarding the directional sign can lead costumers to the petrol station by using the well developed service road with a little delay

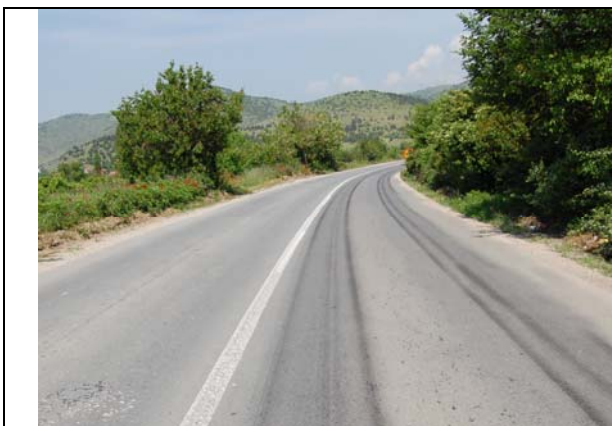
Figure 2.3. Ruttings and bleeding of asphalt

Problem: The lack of evenness in combination with rain and snowfall can lead to serious problems for the driver like aquaplaning. In addition very high risks for powered two wheelers.

Proposal for improvements: Resurfacing

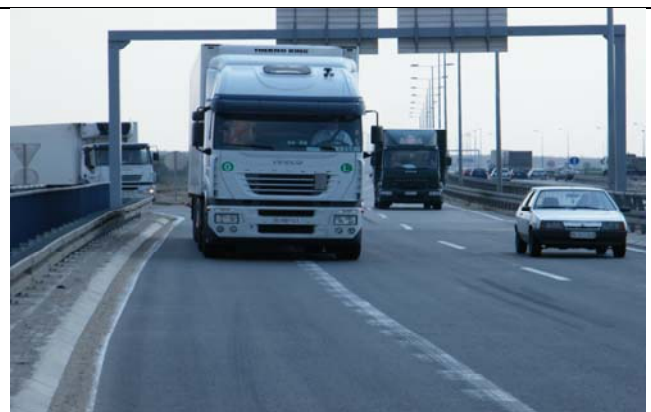
Figure 2.4. Weaving lane to narrow for large vehicles

Problem: A two carriageway express road in a subsection of a split level junction. In a first construction step an interim solution was design with a insufficient lane width for the weaving lane (approx. 2,5 m)

Proposal for improvements: Change of the marking would make it possible to have 3 x 3,0 m wide lanes

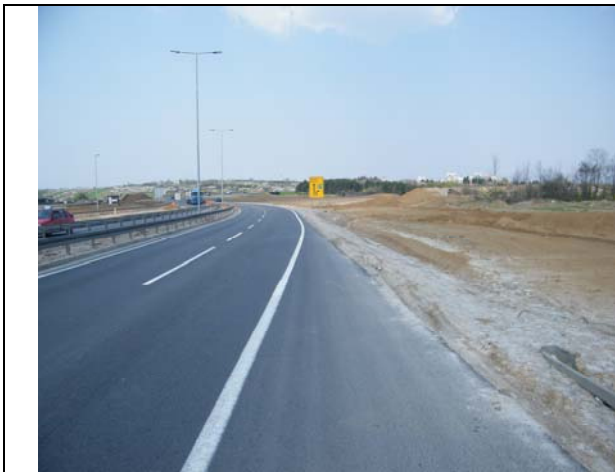
Figure 2.5. Curve sequence with small radii after a long stretched section is not visible

Problem: The curve sequence with small radii after a long stretched section is unexpected for a driver. There are not any measure to support the drivers perception like chevron sign, delinators etc. foreseen.

Proposal for improvements: Add sufficient warning signs, provide obstacle free zone in the outside of the curve (or guardrails) to reduce accident severity in the case of run offs.

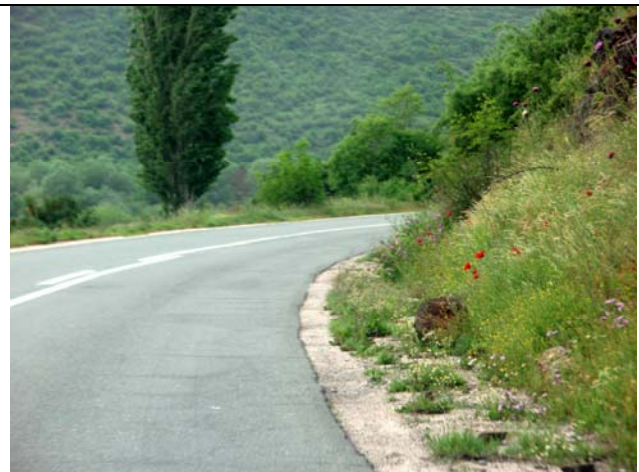
Figure 2.6. Lack of lateral clearance

Problem: Lack of lateral clearance, problem with the stopping sight conditions

Proposal for improvements: Cutting the slope to ensure sight distance

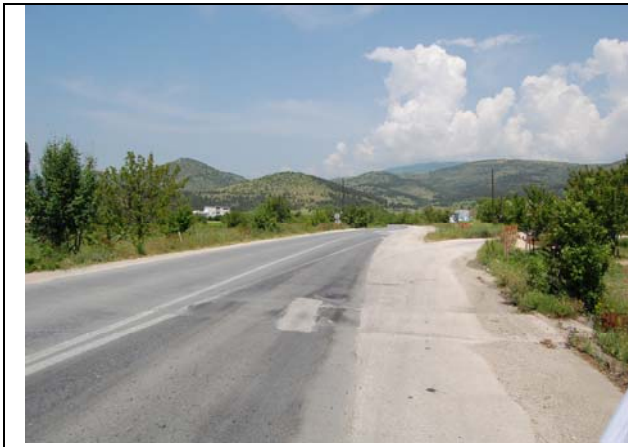
Figure 2.7. “Canalized” junction without marking and signing

Problem: In one road section we found an canalized junction which was obviously constructed some years ago. In the current situation was there not any marking to show the left turning lane and almost all signs were missing.

Proposal for improvements: It should be checked if this junction is still in use. If so, the situation should be improved with a proper marking and signing.

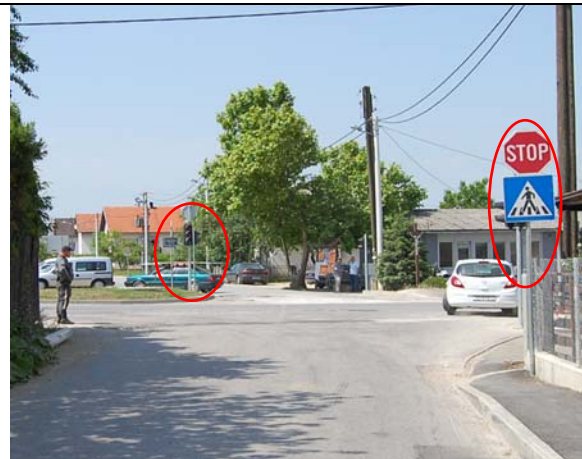
Figure 2.8. Regulation of the traffic with traffic light – bad visibility regarding the signals

Problem: From the secondary leg of a junction the traffic lights (under construction) are hardly recognizable (esp. when the operation will start). One signal is hid by signs, the second is installed on the opposite site of the road.

Proposal for improvements: It should be checked if it is possible to have overhead signals for better visibility.

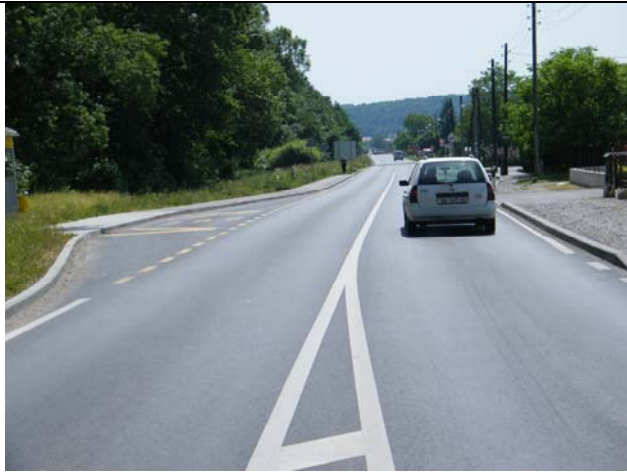
Figure 2.9. Bus-stop with lay-by, lack of crossing facility and connecting footpath

Problem: Good designed bus lay bys with shelter, but no regular pedestrian crossing as well as no sufficient footpath connection to the adjacent built up area.

Proposal for improvements: Marked pedestrian crossing or traffic island as crossing help should be installed, improvements of footpath connection to avoid that pedestrians are forced to use the carriageway.

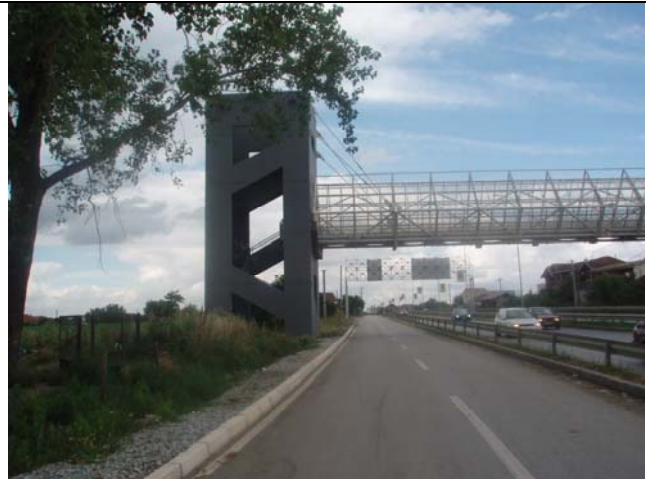
Figure 2.10. Modern pedestrian bridge crossing an express road with adjacent service roads, but lack of connection to guide the pedestrians

Problem: Modern pedestrian bridge crossing an express road with adjacent service roads, but lack of connecting footpaths to guide the pedestrians to that facility.

Proposal for improvements: Parallel footpaths to connect the bridge with the adjacent built up area.

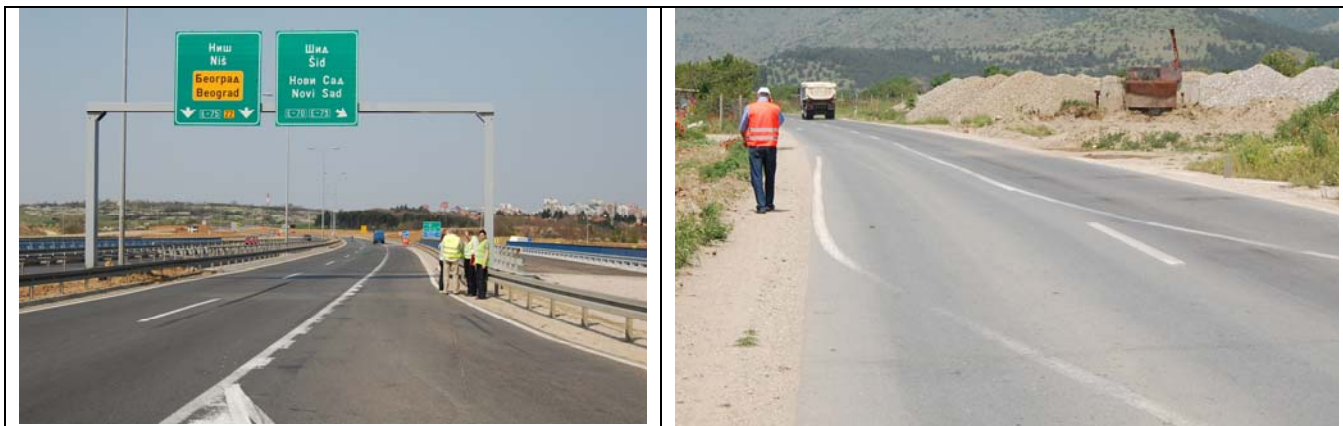
Figure 2.13. Insufficient directional signing solution, misleading marking

Problem: The directional signing does not show the real situation of the three lanes and the complex situation (only 250 m after this interchange is the next one). Also the marking is mixed (broken line with solid line).

Proposal for improvements: Improvement of directional signing, clarify marking

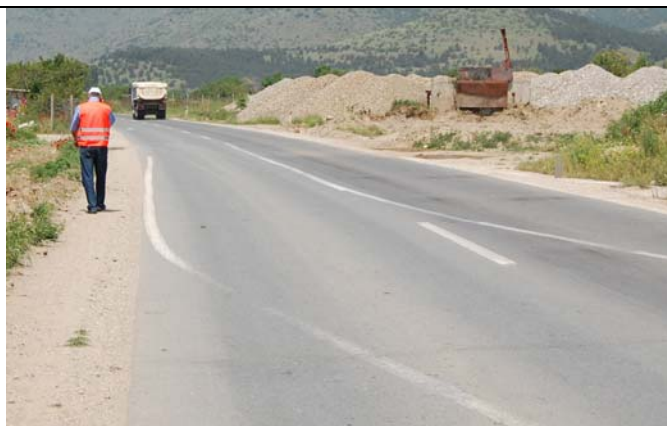
Figure 2.14. Marking in bad condition, old "phantom" marking

Problem: The marking is in the darkness not sufficient and the old "phantom" marking could misguide the driver. is mixed (broken line with solid line).

Proposal for improvements: Renewing of the marking in sufficient quality of for a European TEN roads.

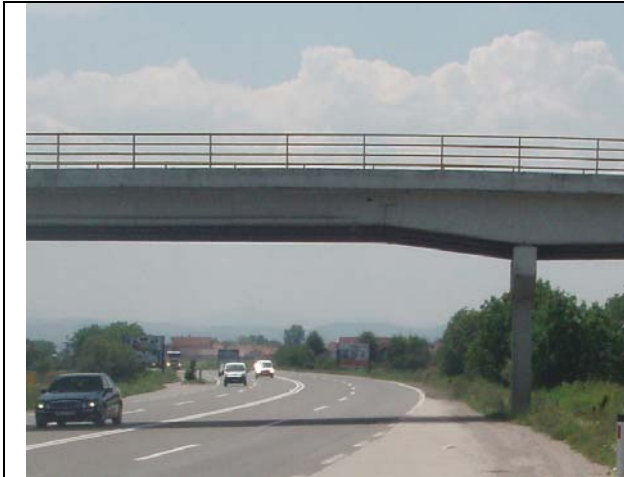
Figure 2.15. Missing guardrail for an overpass bridge pile

Problem: Missing guardrail for an overpass bridge pile along a express road. This is not only a problem of the result for the car which could hit this facility. It could be also a critical situation for the structure in the case of a hit by a big truck (is the structure stable enough).

Proposal for improvements: Installing of a sufficient safety barrier

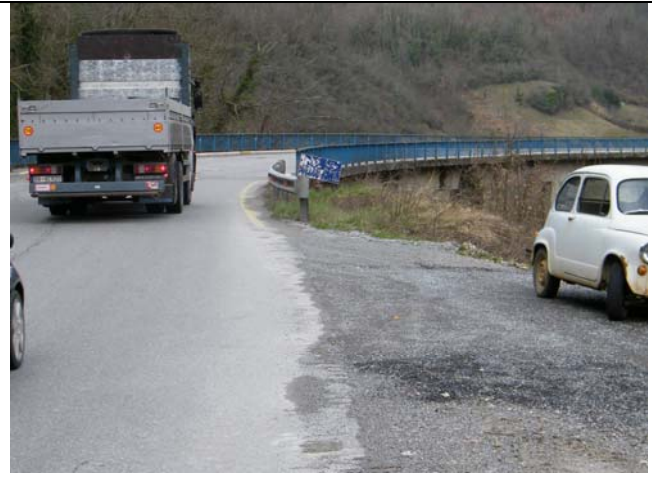
Figure 2.16. Missing guardrail at the bridge section

Problem: Missing guardrail at a viaduct and in the adjacent road section.

Proposal for improvements: Installing of a sufficient safety barrier.
