Support for implementing measures for the South East Europe Core
Regional Transport Network Multi Annual Plan 2008-2012
EuropeAid/125783/C/SER/MULTI

COLLECTION OF RESULTS AND EXAMPLES FROM THE RSI PILOTS IN THE SEETO REGION

Annex 4 to Road Safety Inspection Guideline

July, 2009

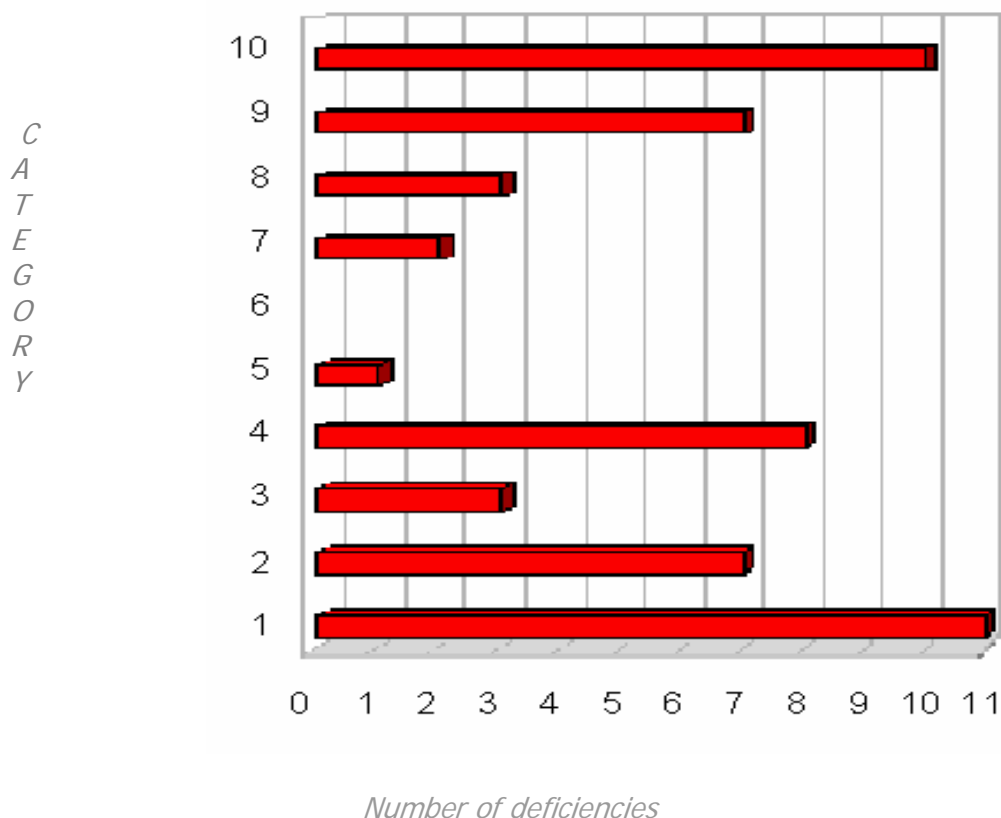
The dedicated graph is suitable to show clear the weak points (x-axes= number of deficiencies and y-axes = categories like in the table above):

The results can be subsuming that the most challenges were identified in the category of the “Road Function, Operation” and in the categories “Marking and Signing” as well as “Passive Safety Installations, Road Side Features”.

Taking into consideration, that it is possible to improve the passive safety installation and the gaps regarding marking and signing with so called “low cost measures” a fast progress on the way to more road safety is realistic.
