Support for implementing measures for the South East Europe Core
Regional Transport Network Multi Annual Plan 2008-2012
EuropeAid/125783/C/SER/MULTI

COLLECTION OF RESULTS AND EXAMPLES FROM THE RSA PILOTS IN THE SEETO REGION

Annex 4 to Road Safety Audit Manual

July, 2009

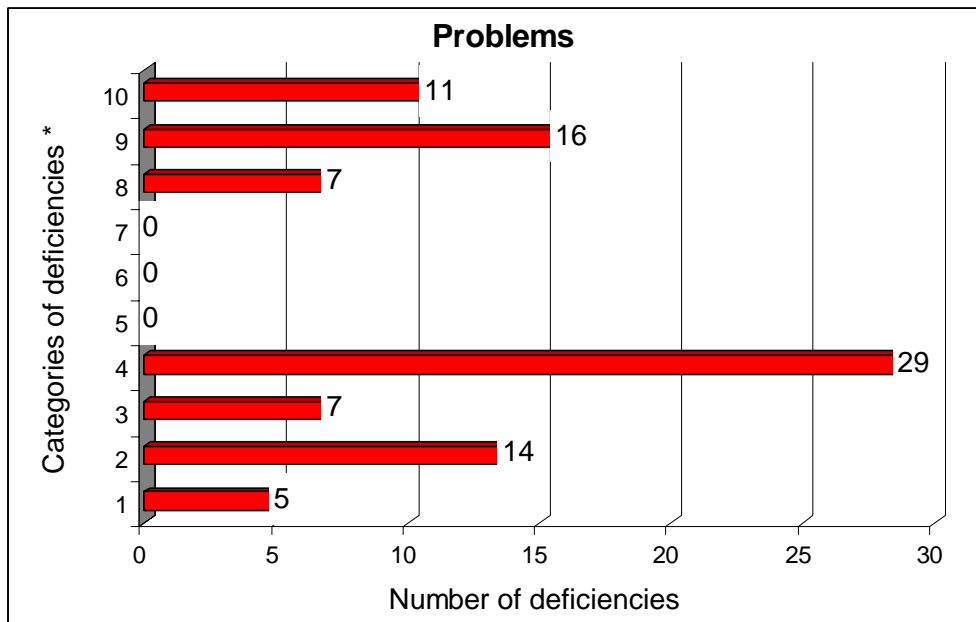
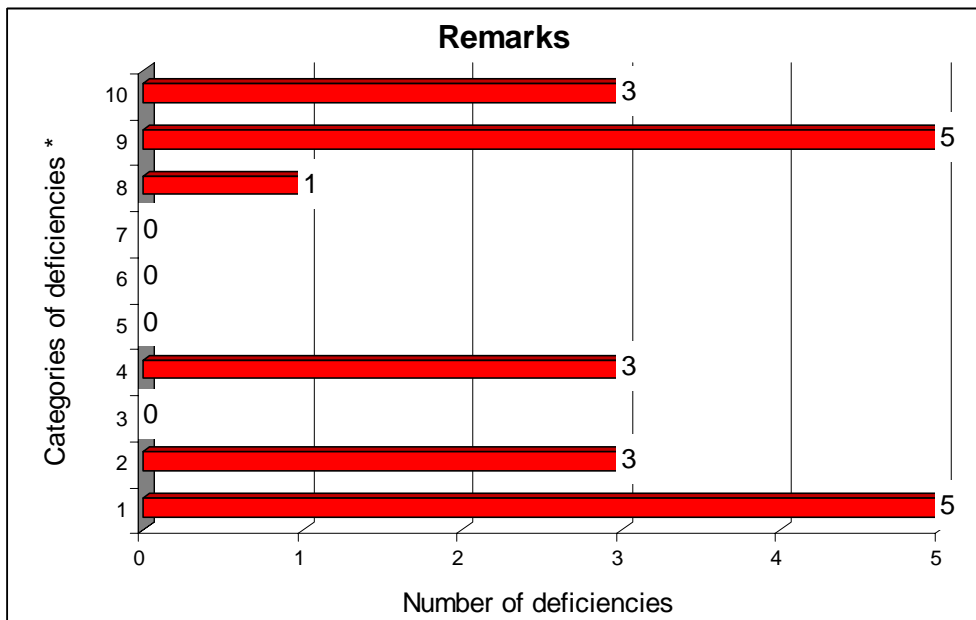
In the following graph the contribution of the problems and remarks is illustrated:

* Categories like in the table above

The main deficiencies are typical design mistakes and with some minor differences in details, the problems were quite similar.
